The 56,000-ton bulk carrier *Sophia D* was severely damaged when it ran aground off the coast of Brazil.

A Most Challenging Project: Repair of the *Sophia D*

BY UWE W. ASCHEMEIER AND KEVIN S. PETERS

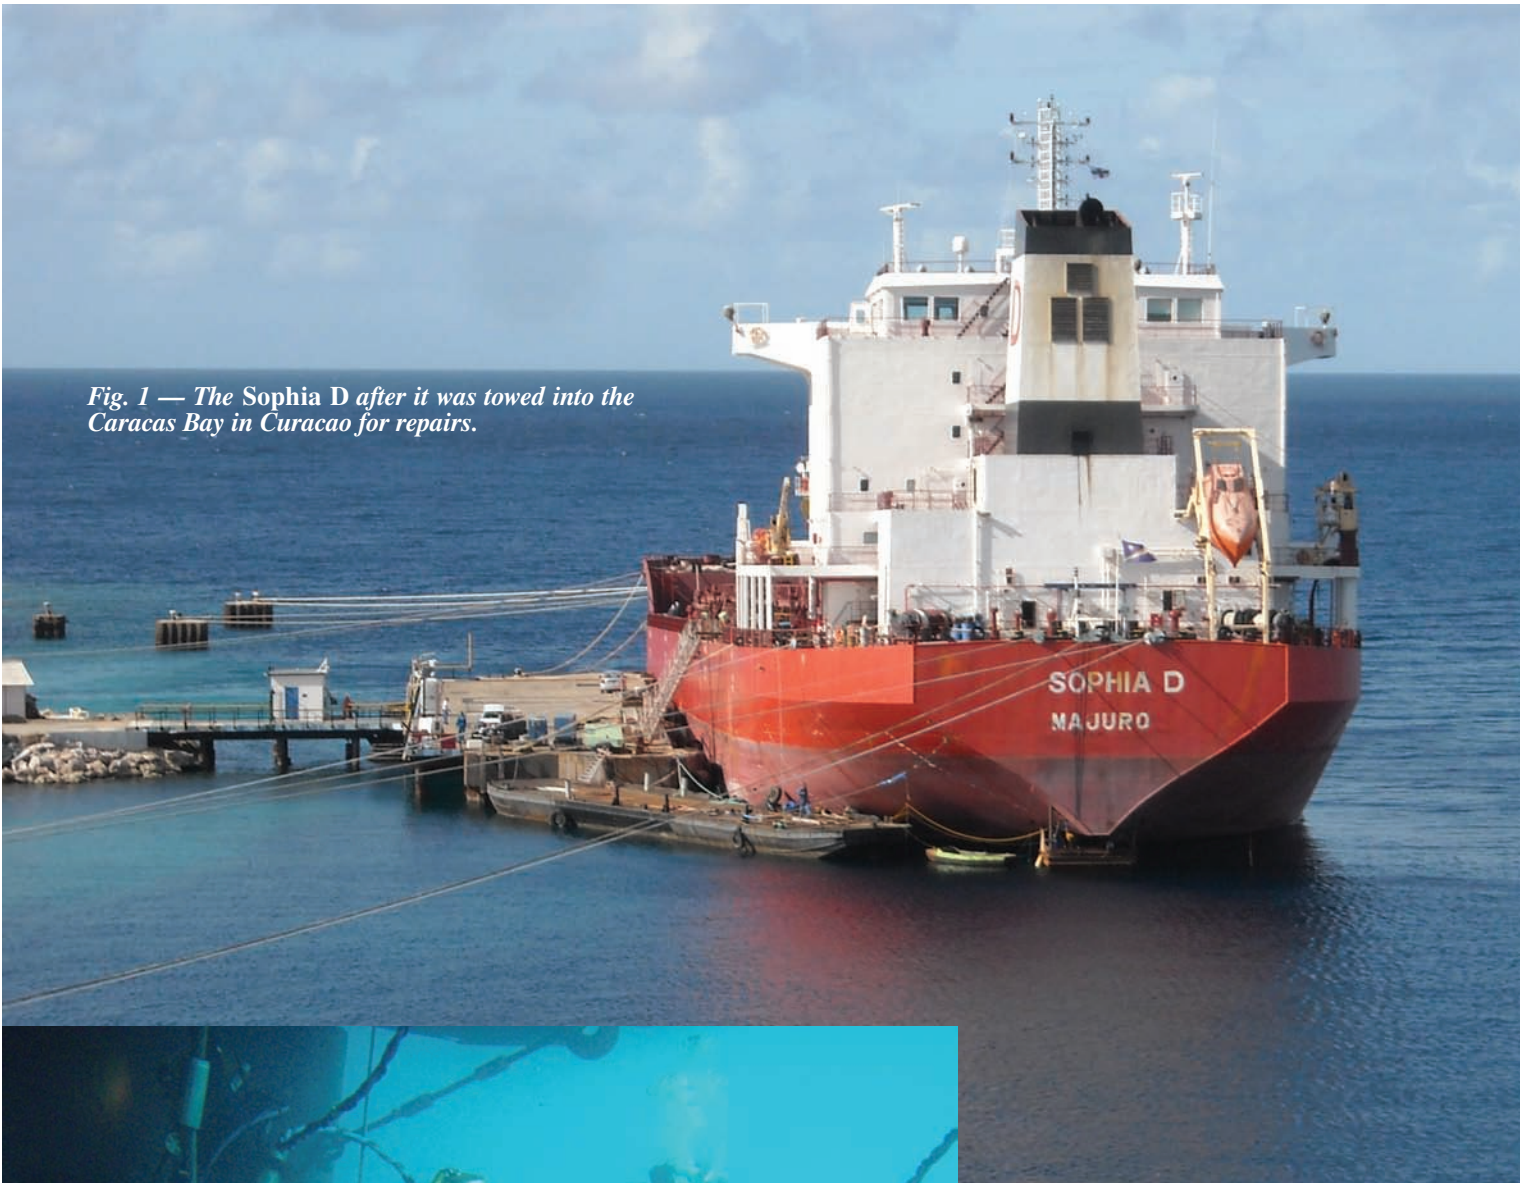
Fig. 1 — The Sophia D after it was towed into the Caracas Bay in Curacao for repairs.

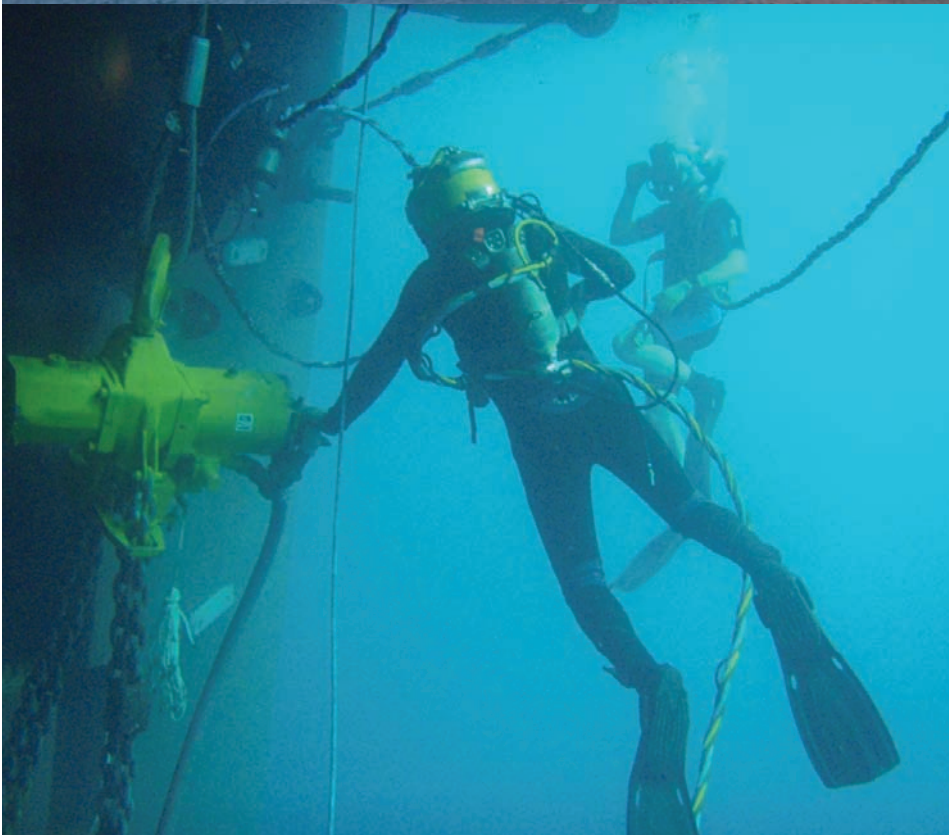
Fig. 2 — Diver operating a 25-ton air chain hoist during removal of the rudder.

Divers from Miami Diver, Parker Diving, All Sea Enterprises, and Trident Diving welded 1-in.-thick, 25-ton rigging pad eyes with $\frac{3}{8}$ -in. fillet welds to connect the air hoists underwater onto the rudder and above the waterline to the ship's hull. All underwater wet welding was performed with the shielded metal arc welding (SMAW) process, using Hydroweld FS electrodes, by diver-welders qualified to the requirements of AWS D3.6M:1999, *Specification for Underwater Welding*. The divers installed four 25-ton air hoists — Fig. 2.

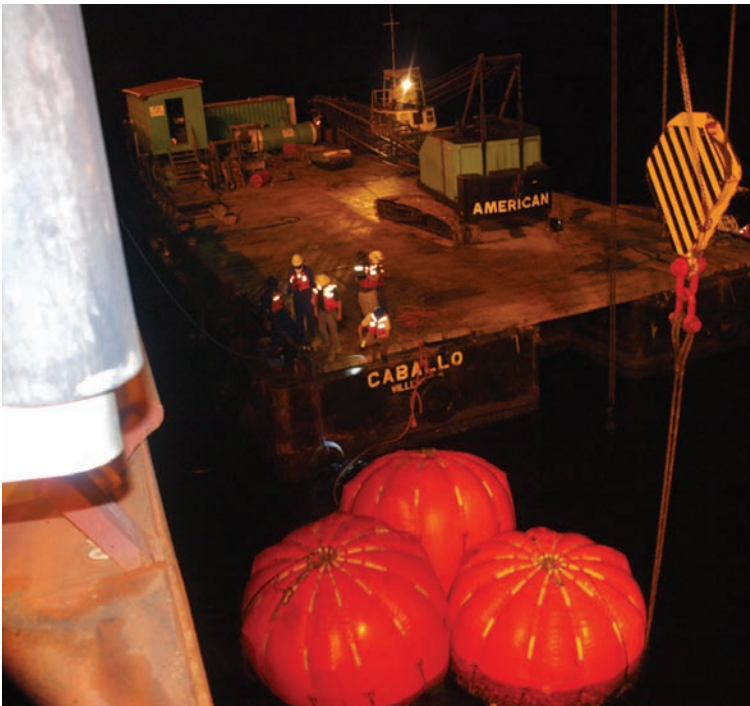
Fig. 3 — The rudder hanging from the lift bags.

The freed rudder blade was lowered on the four air hoists and transferred aft to four 15-ton lift bags — Fig. 3. The rudder blade was towed to the backside of the ship and a preset rigging was attached to perform a two-crane pickup using two of the ship's 35-ton cargo cranes. The rudder blade was then loaded onto the barge and brought to the shipyard.

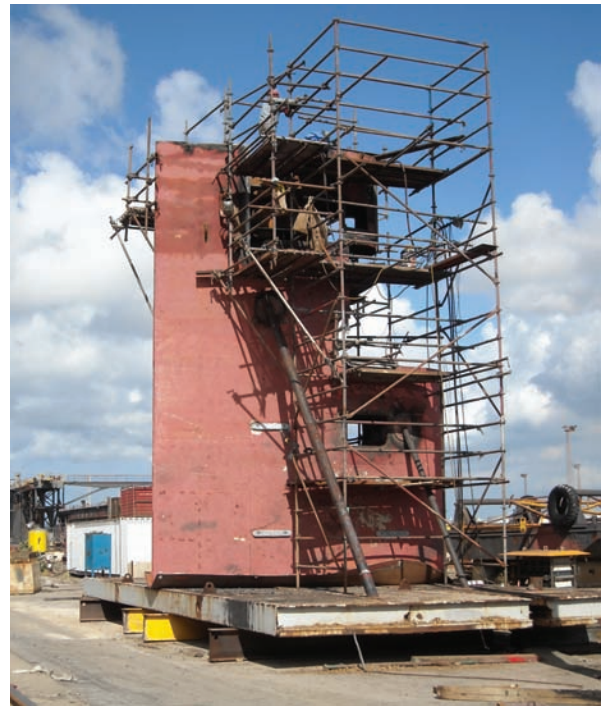
Fig. 4 — The rudder in the shipyard.

The rudder repair was performed in the shipyard in Curacao — Fig. 4. An inspection of the rudder revealed severe damage, which included the following:

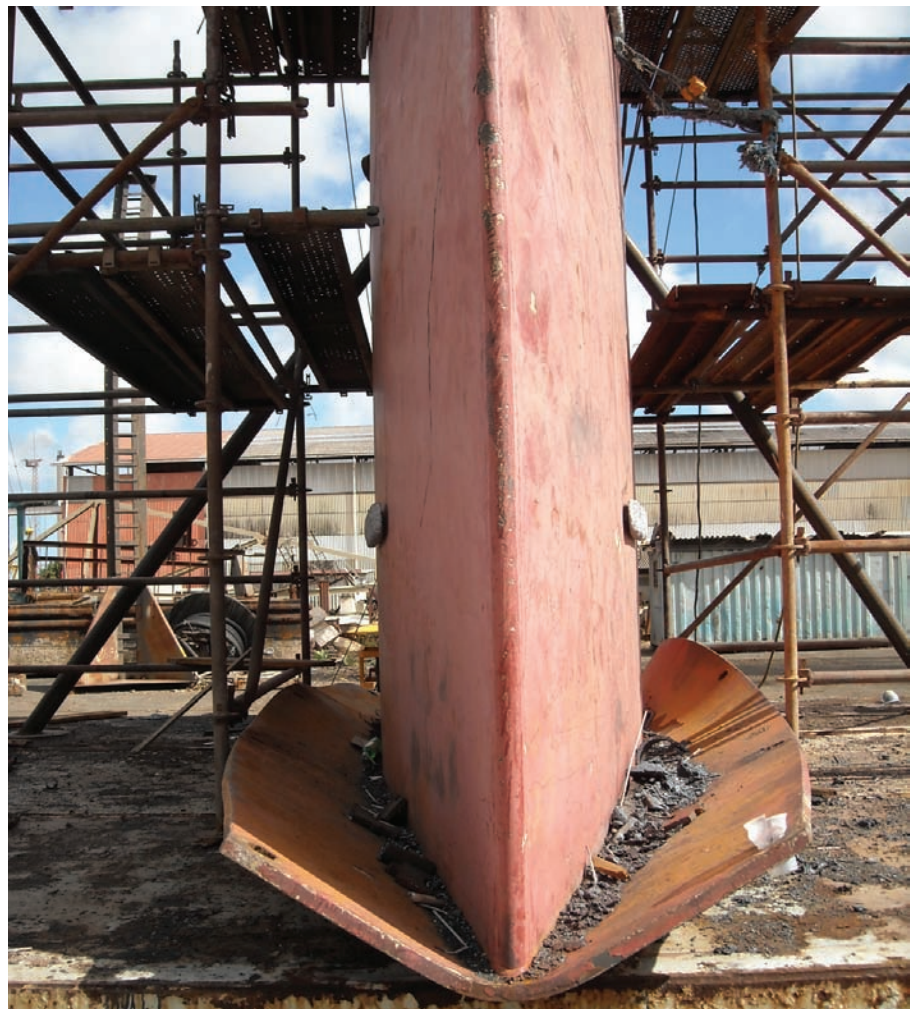
- The upper and lower castings on the rudder blade were misaligned.
- The 1.75-in.-thick rudder bottom plate was bent upward to an angle of 45 deg — Fig. 5.
- The skin plates on the port and starboard side as well as the top plate were buckled.
- After those skin plates were cropped

Fig. 5 — The bent rudder bottom plate.

The 1.75-in.-thick plate mounted to the bottom of the rudder was bent so badly (Fig. 5), it had to be trimmed approximately 1 in. overlapping the edge of the rudder skin before the rudder could be reinstalled onto the vessel. The plate helps with the steering of the vessel at slow speeds.

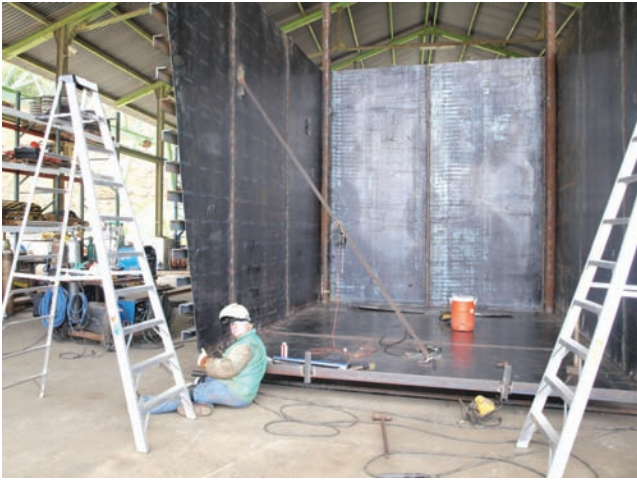
Fig. 6 — Welder Bruce Smythe at work building the 23,000-lb cofferdam.

A marine engineer specifically designed a cofferdam for this job that would displace 130 cubic yards of water. The cofferdam was installed around the rudder horn after the rudder was removed. The approximately 15-ft-long, 13-ft-wide, and 14-ft-tall cofferdam was built out of ¼-in.-thick ASTM A36 steel, reinforced with 4 × 4 × ¾-in. angles at the bottom and the sidewalls — Fig. 6.

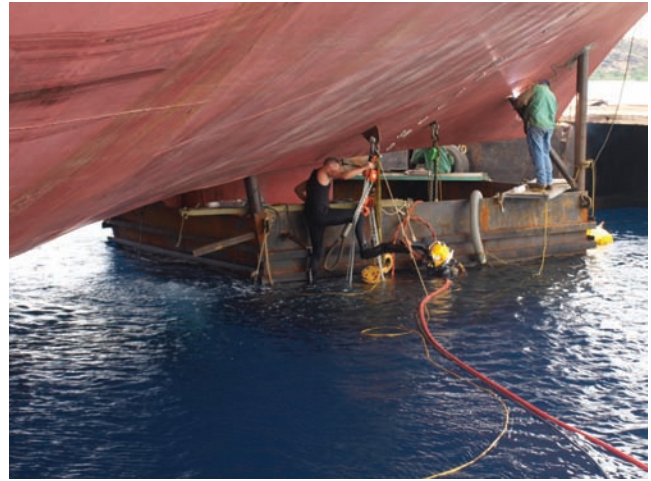
Fig. 7 — Installing the cofferdam.

After the cofferdam was finished, it was transported to the vessel, lowered into the water, lifted up, and welded to the ship's hull — Fig. 7. Once installed, 30 tons of cargo had to be moved to the forward compartments allowing the ship to trim the cofferdam 3 ft above the waterline. The cofferdam was dewatered to enable evaluation of the damage to the rudder horn and the aft peak tank.

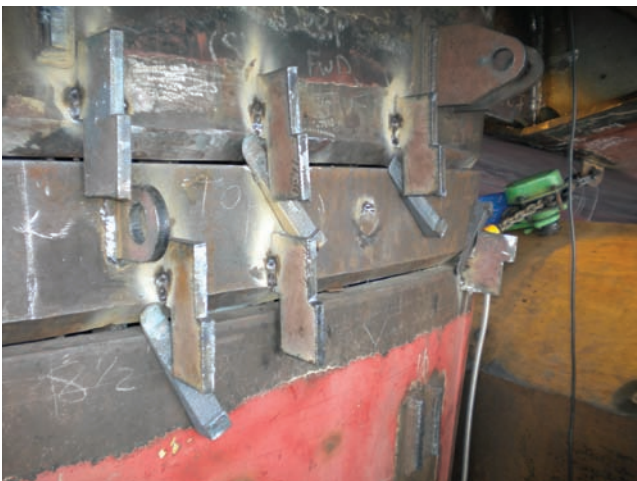
Fig. 8 — Joint preparation on the insert on the port side.

The 8-in.-tall plate insert on the port and starboard sides, as well as the nose insert plate, were tacked in place and strongbacks were welded onto the backside of

the joint — Fig. 8. Run-off plates were welded at the ends of the welding joints.

Joint preparation was a single bevel groove weld with a 45-deg opening angle on top. This allowed the lower part of the joint to be used as a shelf. The root opening was held at approximately $\pm \frac{1}{8}$ in.

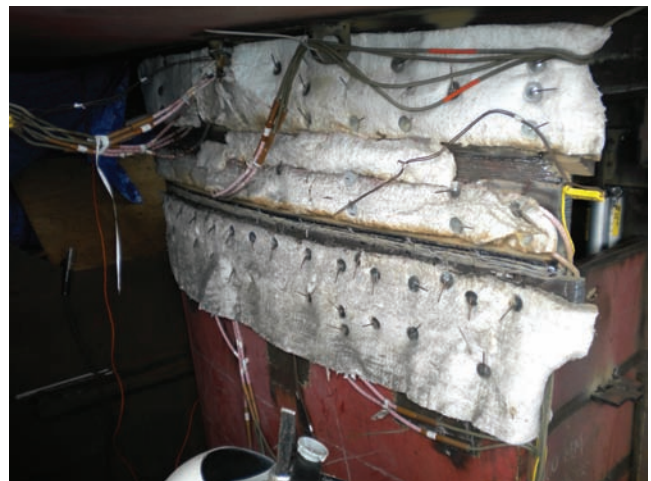
Fig. 9 — Ceramic heating elements and insulation are shown installed at the joint to be welded.

After alignment of the inserts was confirmed, ceramic heating elements and insulation pads were installed to maintain the preheat temperature and to reduce the cooling rate of the finished welds — Fig. 9. After approximately two hours the 225°F preheat temperature was achieved and the root could be welded. Preheat and minimum interpass temperatures were maintained during the welding operation for a distance not less than 3 in. in all directions from the point of welding.

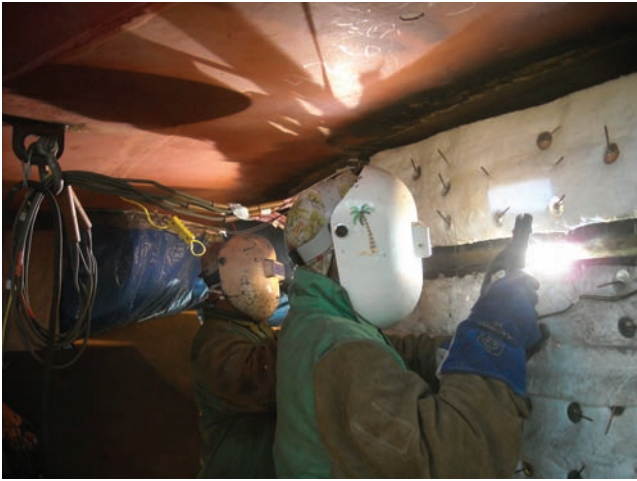
Fig. 10 — Two welders working simultaneously on the portside joint.

The two upper joints on the port and starboard side were welded first. The root passes on the upper weld joints were welded simultaneously by two welders, each working on one side. They worked in a predetermined welding sequence, starting from the center to the outside. Four welders working at the same time, two on each side (Fig. 10), welded the fill and cover passes. Welding was accomplished in two 12-h shifts.

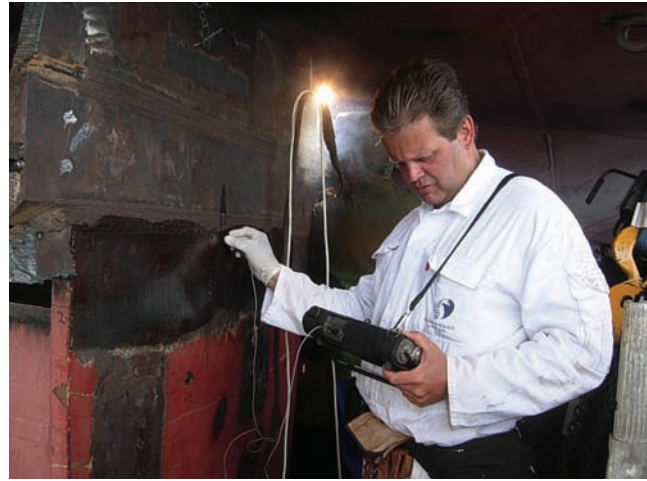
Fig. 11 — Inspector Mark Thury performing an ultrasonic inspection of a complete-joint-penetration weld.

Det Norske Veritas required 100% visual inspection of all welds, magnetic particle testing on root passes of all welds on insert plates, and ultrasonic inspection of all complete-joint-penetration welds — Fig. 11. In addition, leak testing had to be performed on all watertight compartments. After Thury passed the inspected items, the DNV surveyor performed a verification inspection.

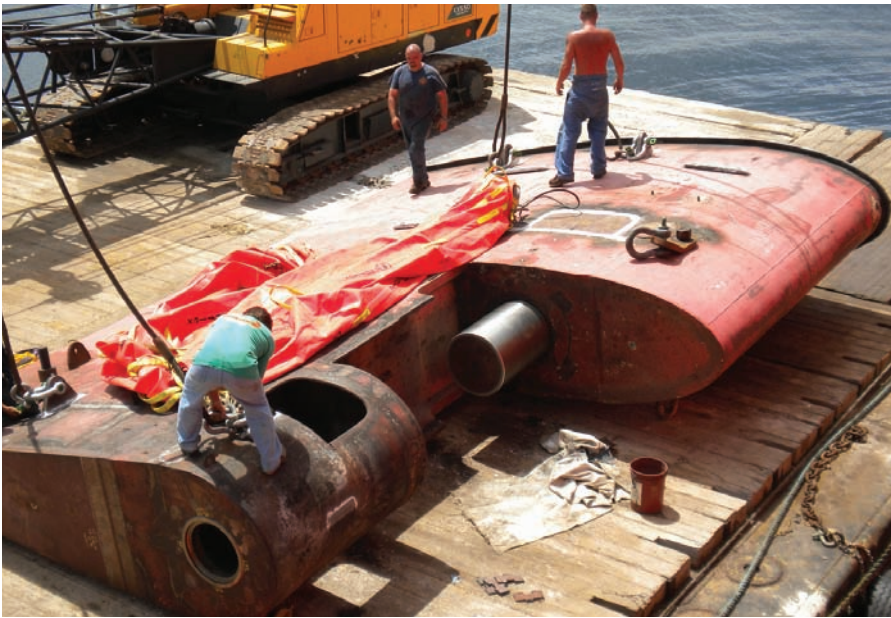
Fig. 12 — The rudder on the barge deck awaiting reinstallation.

With the completion of all repairs, divers removed the cofferdam. The rudder also had to be reinstalled (Fig. 12), as well as the rudder stock and the steering gear foundation.
