MV Jialong Spirit

By/Par Uwe W. Aschemeier and/et
Kevin S. Peters

Leaking Welds

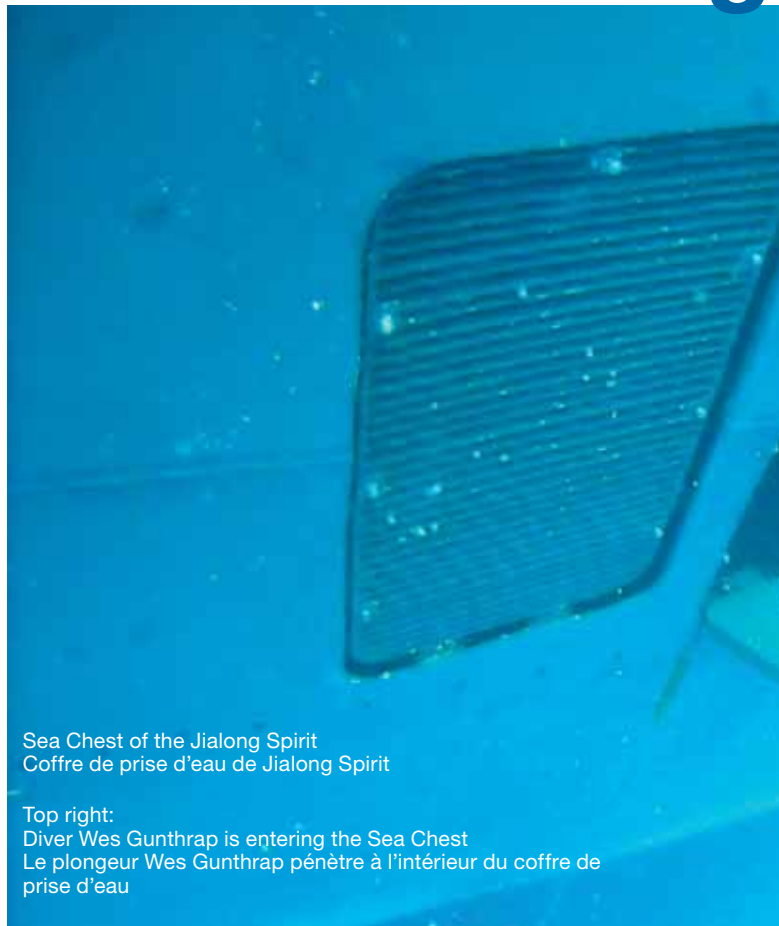
Sea Chest of the Jialong Spirit
Coffre de prise d'eau de Jialong Spirit

Top right:
Diver Wes Gunthrap is entering the Sea Chest
Le plongeur Wes Gunthrap pénètre à l'intérieur du coffre de prise d'eau

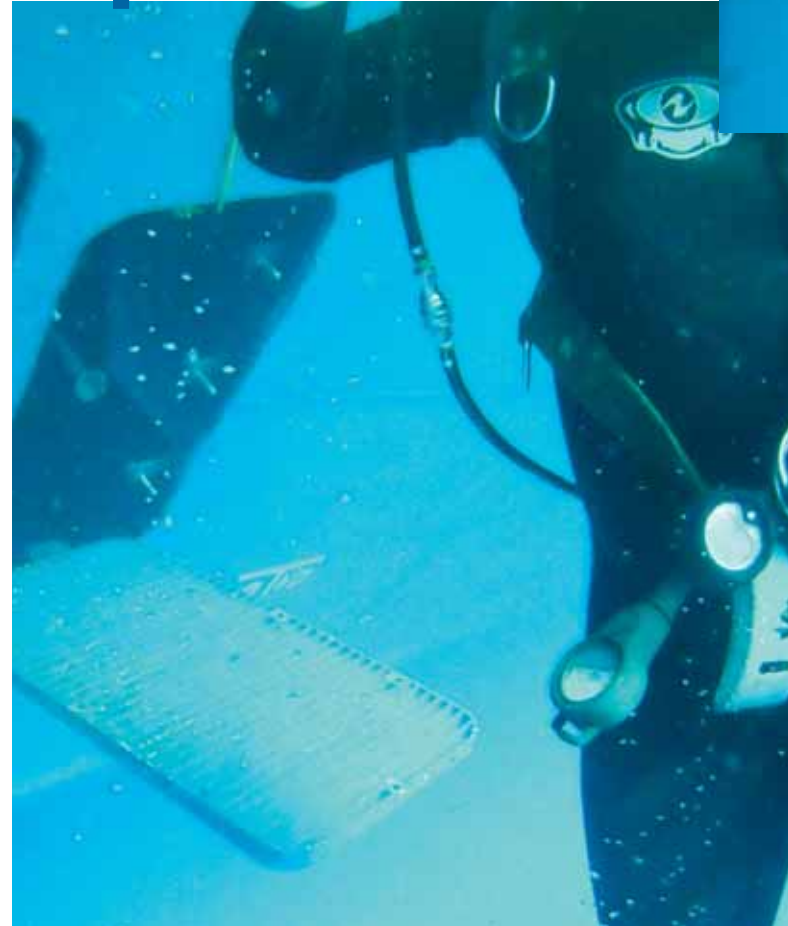
Diver Wes Guntharp is performing Magnetic Particle Testing Under Water. The extent of the discontinuities was established by Visual (VT) and Magnetic Particle Inspection (MT) according to ASTM E709.

Le plongeur Wes Guntharp effectue un examen magnétoscopique sous l'eau. L'étendue des discontinuités a été établie au moyen d'un examen magnétoscopique conformément à la norme E709 de l'ASTM.

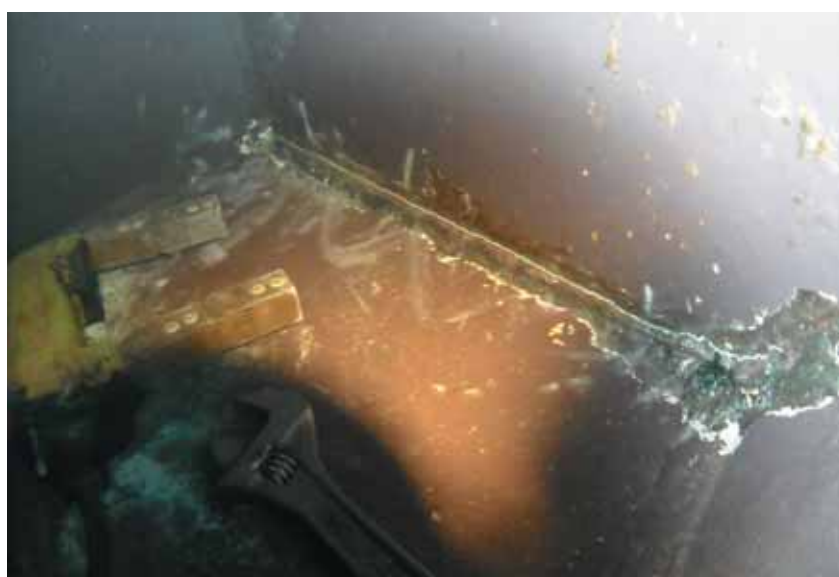
Crack like indication in the top of the weld.

Petite fissure dans le talon de soudure.

A crack like indication was observed in the top toe of the weld on the port side, where the aft wall plate is connected to the inner bottom plate of the sea chest at frame 52.

to the procedure. It was agreed by the ship's superintendent, the chief engineer and the attending surveyor to remove the crack by arc gouging from the inside of the sea chest (dry and clean), weld from the inside of the sea chest, back gouge and re-weld in the dry from the outside of the sea chest.

Both ends of the crack were arrested by drilling Ø3 mm holes. While removing the fracture using the carbon arc method, it was observed that the installed vertical aft plate of the sea chest exhibited a gap in excess of 6 mm and the void space between the horizontal and vertical plate was filled with slag. After carbon arc gouging and prior to welding the root, liquid penetrant inspection was performed to ensure the complete removal of the crack.

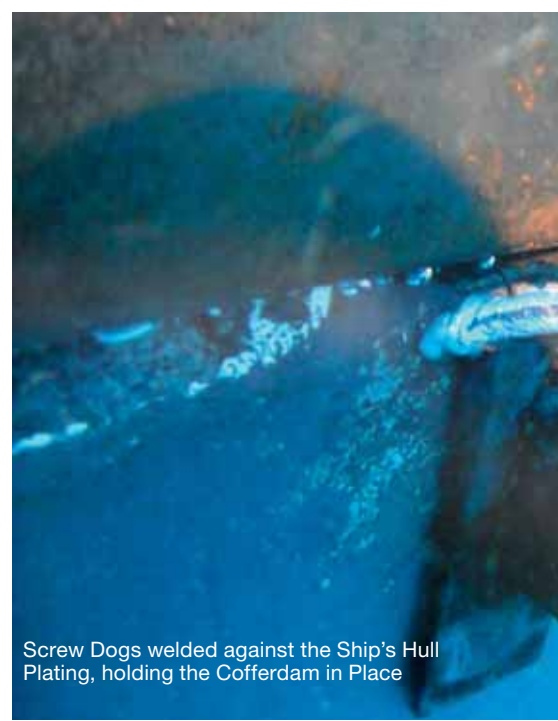
Screw Dogs welded against the Ship's Hull Plating, holding the Cofferdam in Place

The sea chests grates on the port and starboard sides were sealed underwater by covering them with seal plates/cofferdams and 24 mm thick close-cell neoprene gaskets. The plates were fabricated out of 6.3 mm thick plate material were attached with welded screw fixtures to the hull.

The screw dogs were welded underwater in the wet, employing the shielded metal arc welding (SMAW) process. When welding in the wet, Miami Diver's welding procedures always call for multiple pass welds. The welding consumable used was the Hydroweld FS electrode. According to AWS D3.6 – Underwater Welding Code, the filler metal manufacture and the trade name of the electrode are essential variables. Once a welding procedure is approved with a certain welding consumable, this consumable has to be used in production.

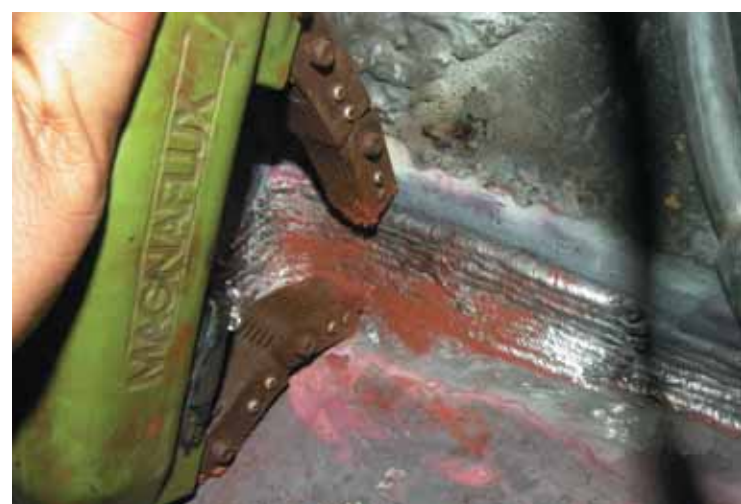
VT and MT were performed after the crack was repaired
 Un examen visuel et un examen magnétoscopique sont effectués une fois la fissure réparée

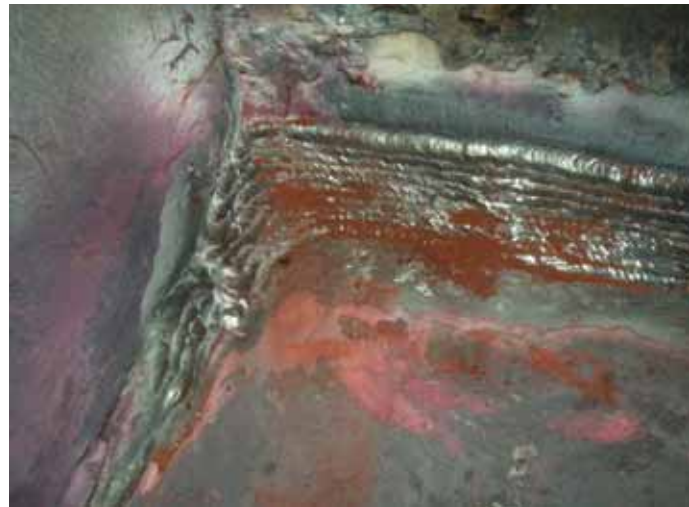
Final repair weld on the inside between the AFT wall plate and the inner bottom plate of the sea chest at frame 52.

Une soudure de réparation finale est réalisée à l'intérieur du coffre, entre la plaque murale ARRIÈRE et la plaque inférieure interne du coffre au niveau du couple 52.

a crack on the inside of the sea chest, approximately 50 mm long, top of the weld, towards the longitudinal sea chest wall.

The crack was drill stopped, arc gouged and cleaned by grinding. Prior to rewelding, liquid penetrant inspection was performed. After completion and a cool down period of 4 hours, visual and magnetic particle inspection was performed. No crack-like indications were found.
