MV Jialong Spirit

By/Par Uwe W. Aschemeier and/et
Kevin S. Peters

Leaking Welds

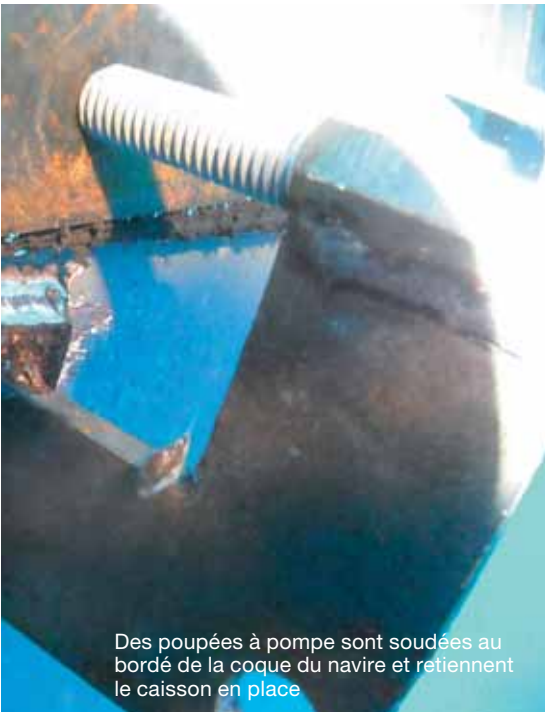
Des poupées à pompe sont soudées au bordé de la coque du navire et retiennent le caisson en place
